Sensor-Operated Plumbing Fixtures

Do They Save Water?

March, 2010

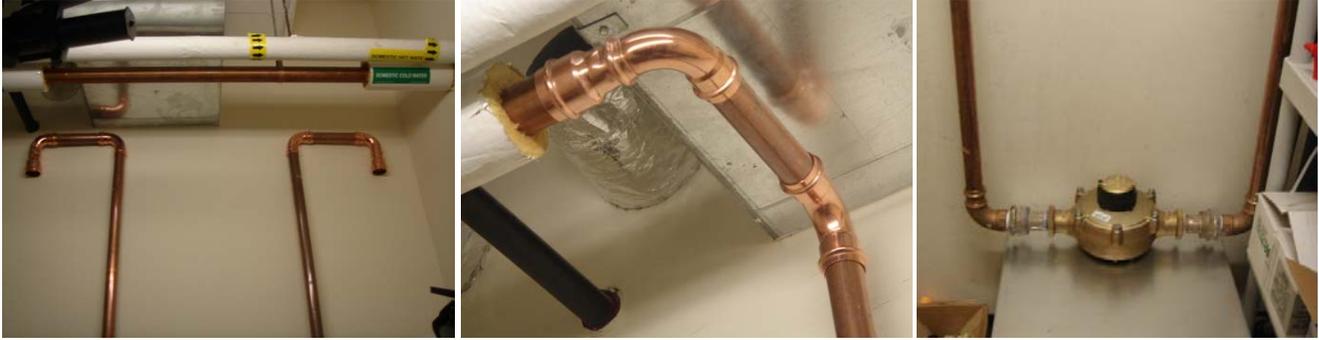
The above photographs show existing supply piping, piping modifications, and the new water meter.

A plumbing company was hired to install a water meter on the supply piping⁵ and a datalogger was connected to the water meter during the entire monitoring period. Because it was necessary to take weekly water meter readings as part of the project, the water supply piping was re-routed such that the water meter could be installed below eye level, on a small table against the back wall of the janitor's closet (see photos on next page).

A datalogger (Brainard Meter-Master 100) was installed on the meter and Tampa Bay Water Conservation staff periodically read the meter and downloaded the information from the data logger on a bi-weekly basis.

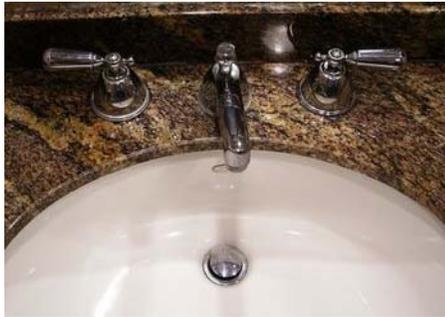
Existing Faucet – general area

The existing faucets in the mens' and ladies' washrooms were two handle, single spout models, with larger handles and a gooseneck spout on the sinks located in the handicap stalls (see photos on following page). These were replaced with new sensor-operated faucets on January 29, 2008. The new faucets were graciously donated to the project by Sloan Valve Company⁶.

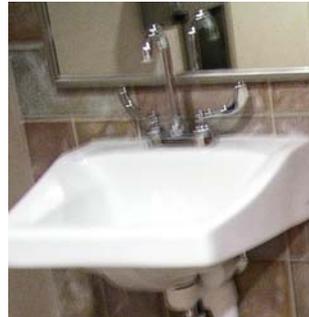
Existing Faucet – handicap stall

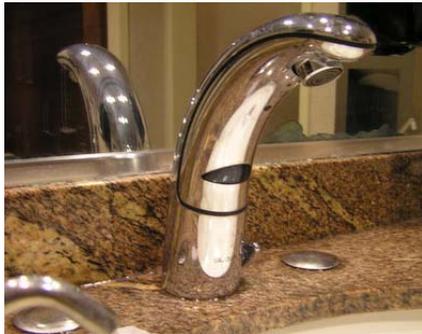
Sensor-operated Faucet – general area

The average flow rate of the manual faucets was measured as 1.32 gallons per minute (with the valve fully open) and the average flow rate of the sensor faucets was slightly less at 1.21 gallons per minute (valve fully open). Water demands were monitored for the 127-day period from the date of installation until June 4, 2008. The average daily water demand of the washrooms during this period was 856 gallons per day – an increase of 202 gallons or 30% per day. Figure 2 on the

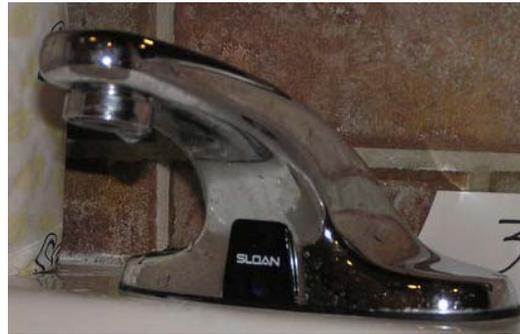
Sensor-operated Faucet – handicap stall

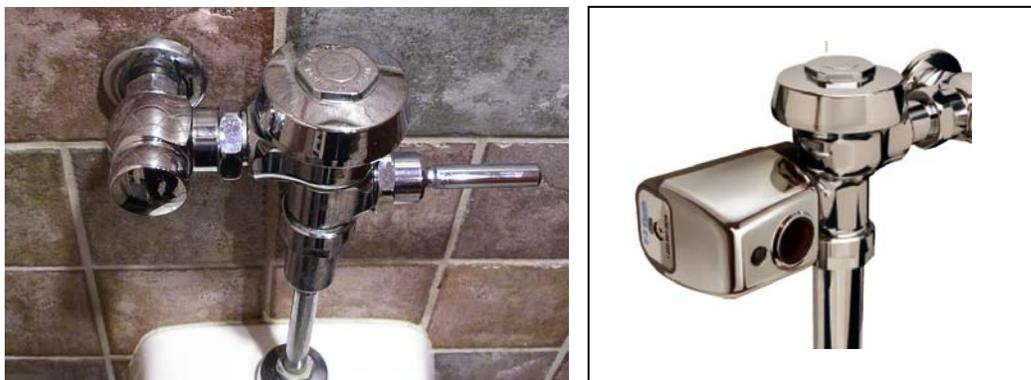
To ensure that any change in water demands was related to a change in the operating system utilized by the flush valve rather than in a change to the flush valve itself, it was decided that rather than replace the existing flush valves, the project would, instead, simply replace the existing manual flush handles on the urinals with battery-powered retrofit sensor-operated valves graciously provided by Zurn (AquaSense® E-Z Flush – see photos below).
