Sensor-Operated Plumbing Fixtures

Do They Save Water?

March, 2010

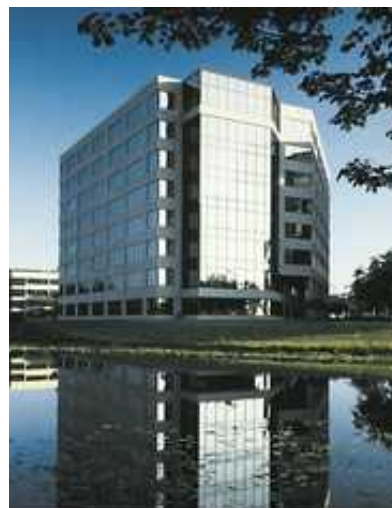
Following physical inspections and interviews with building managers, the LakePoint Two property at 3111 West Dr. Martin Luther King Blvd., Tampa (photo to right), was found to be ideally suited for participation in this project. The LakePoint Two building is an 8-story, 223,000 ft² (net rentable) office building located in the 1.1 million ft² Tampa Bay Park. The building had readily accessible water supply piping and all toilet/urinal/faucet valves were manually operated. Furthermore, building management was willing to allow the installation of sub-metering and monitoring equipment, and to allow a member of the project team to visit the site on a weekly basis to download the information from the data logging equipment.

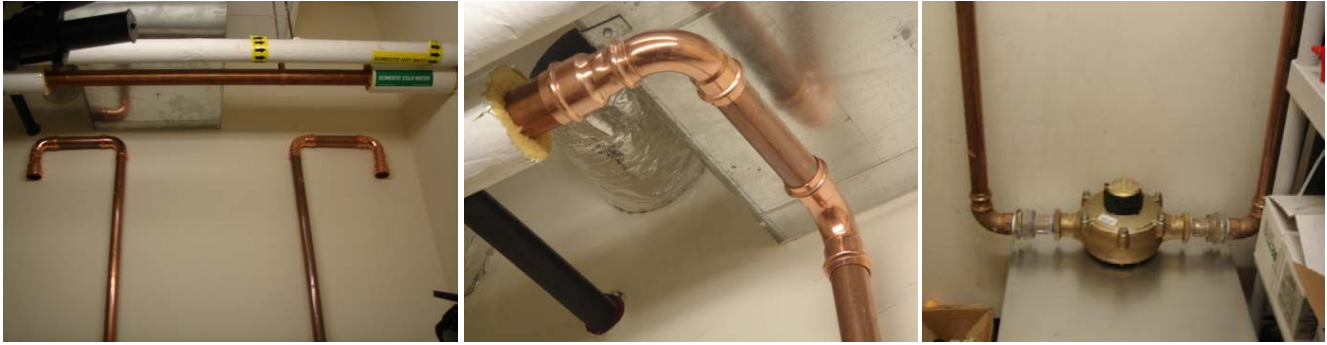
The above photographs show existing supply piping, piping modifications, and the new water meter.

A plumbing company was hired to install a water meter on the supply piping⁵ and a datalogger was connected to the water meter during the entire monitoring period. Because it was necessary to take weekly water meter readings as part of the project, the water supply piping was re-routed such that the water meter could be installed below eye level, on a small table against the back wall of the janitor's closet (see photos on next page).

A datalogger (Brainard Meter-Master 100) was installed on the meter and Tampa Bay Water Conservation staff periodically read the meter and downloaded the information from the data logger on a bi-weekly basis.

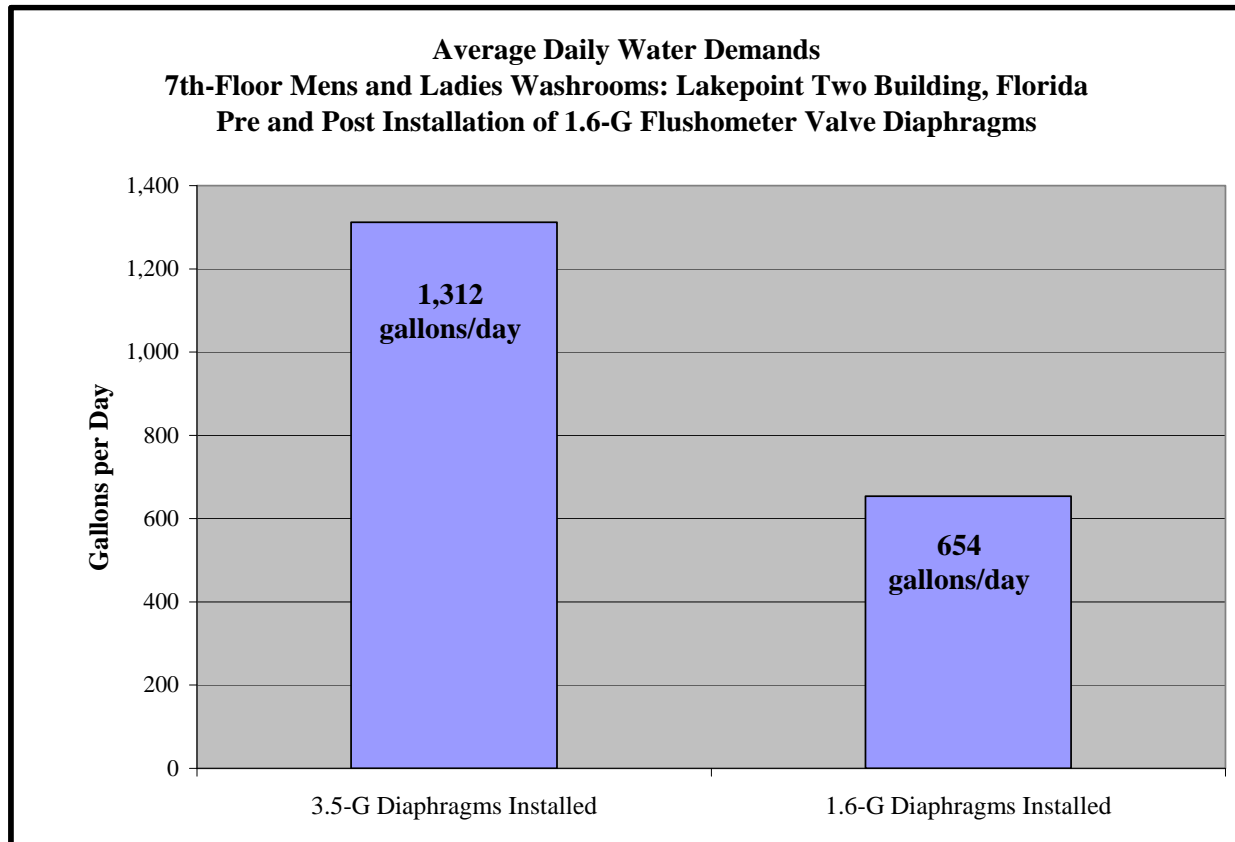
Because of scheduling difficulties, the second round of pre-monitoring was conducted from February 2007 until January 2008 – almost a full year. Figure 1 on the following page illustrates the average daily water demands of the washrooms both prior to and subsequent to the replacement of the 3.5-gpf diaphragms with 1.6-gpf models. As illustrated in Figure 1, a significant volume of water was saved simply by installing the proper diaphragms.

As stated earlier, pre-monitoring of the existing fixtures (after the 1.6-G diaphragms were installed) was conducted from February 2007 until January 2008. The average daily water demands during this period was 654 gallons per day.

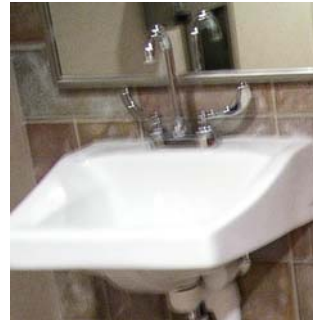
Existing Faucet – handicap stall

The existing faucets in the mens' and ladies' washrooms were two handle, single spout models, with larger handles and a gooseneck spout on the sinks located in the handicap stalls (see photos on following page). These were replaced with new sensor-operated faucets on January 29, 2008. The new faucets were graciously donated to the project by Sloan Valve Company⁶.

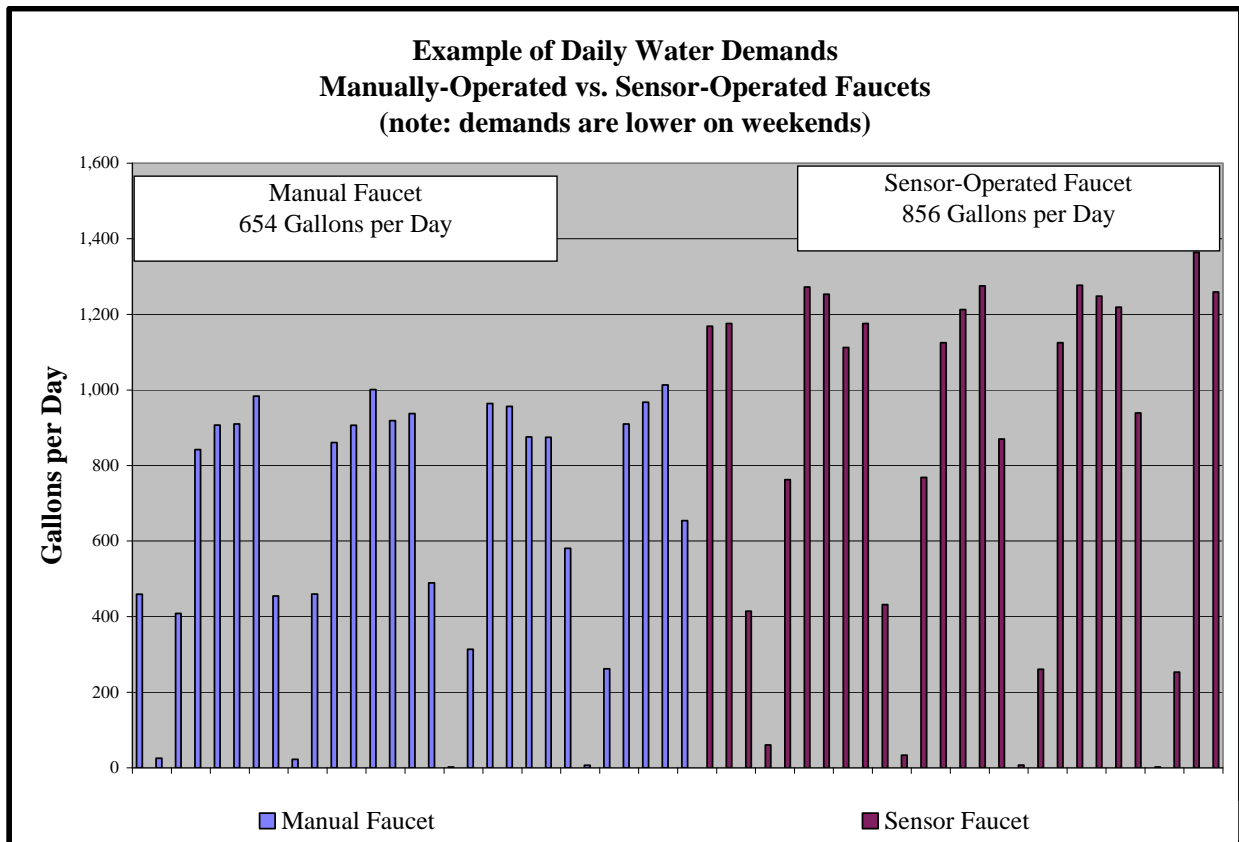
The average flow rate of the manual faucets was measured as 1.32 gallons per minute (with the valve fully open) and the average flow rate of the sensor faucets was slightly less at 1.21 gallons per minute (valve fully open). Water demands were monitored for the 127-day period from the date of installation until June 4, 2008. The average daily water demand of the washrooms during this period was 856 gallons per day – an increase of 202 gallons or 30% per day. Figure 2 on the

following page illustrates the change in water demands when the sensor-operated fixtures were installed. Note that only a portion of the pre and post data is included in Figure 2 to make the chart easier to read.

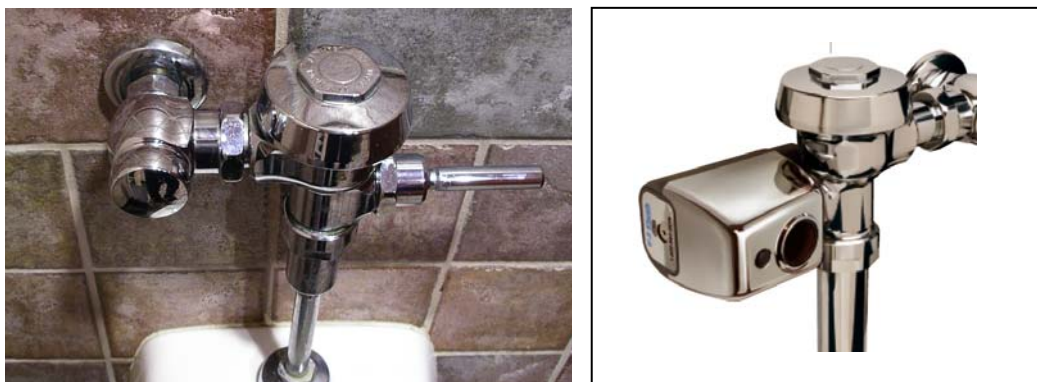
To ensure that any change in water demands was related to a change in the operating system utilized by the flush valve rather than in a change to the flush valve itself, it was decided that rather than replace the existing flush valves, the project would, instead, simply replace the existing manual flush handles on the urinals with battery-powered retrofit sensor-operated valves graciously provided by Zurn (AquaSense® E-Z Flush – see photos below).

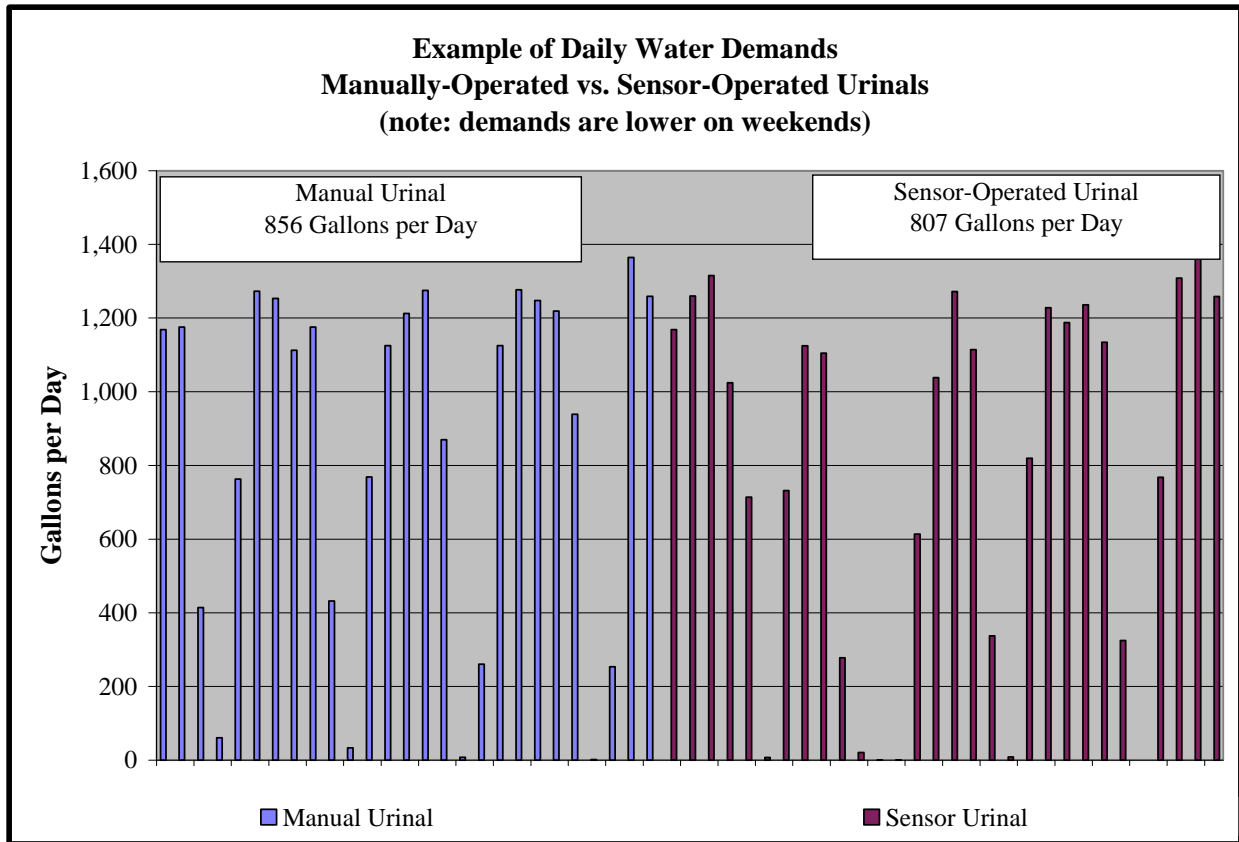
The two manually-operated urinal flush valve handles were replaced with sensor-operated devices on June 4, 2008. No further changes were made to the plumbing fixtures until August 25, 2008 when the existing manually-operated toilet flush valve handles were likewise replaced with sensor-operated devices. As such, the water savings resulting from the installation of the sensor-operated urinal flush valves is based on the water demand data collected between June 4 and August 25, 2008. Note that this period of data collection coincides with the typical “summer vacation” period, i.e., it is likely that staff occupancy at the site during this period was lower than during other non-summer periods (this monitoring period was only included in the study because the project was behind schedule). Unfortunately, the project team was not able to obtain staff occupancy data for this period of time.

While the average water demands between June 4 and August 25 declined by approximately 5.5% vs. the period from January 29 until June 4, 2008 (856 gallons per day before installation of sensor-operated urinal flush valves and 807 gallons after installation), it is expected that most of this savings is related to lower occupancy rates during the post monitoring period rather than a decrease in urinal-related water demands. As can be seen in Figure 3 on the next page, the peak daily demand rate is similar during both the pre and post sensor-operated urinal monitoring period (the average of the days with demands greater than 1,000 gallons vary by only 1% between pre- and post-monitoring).

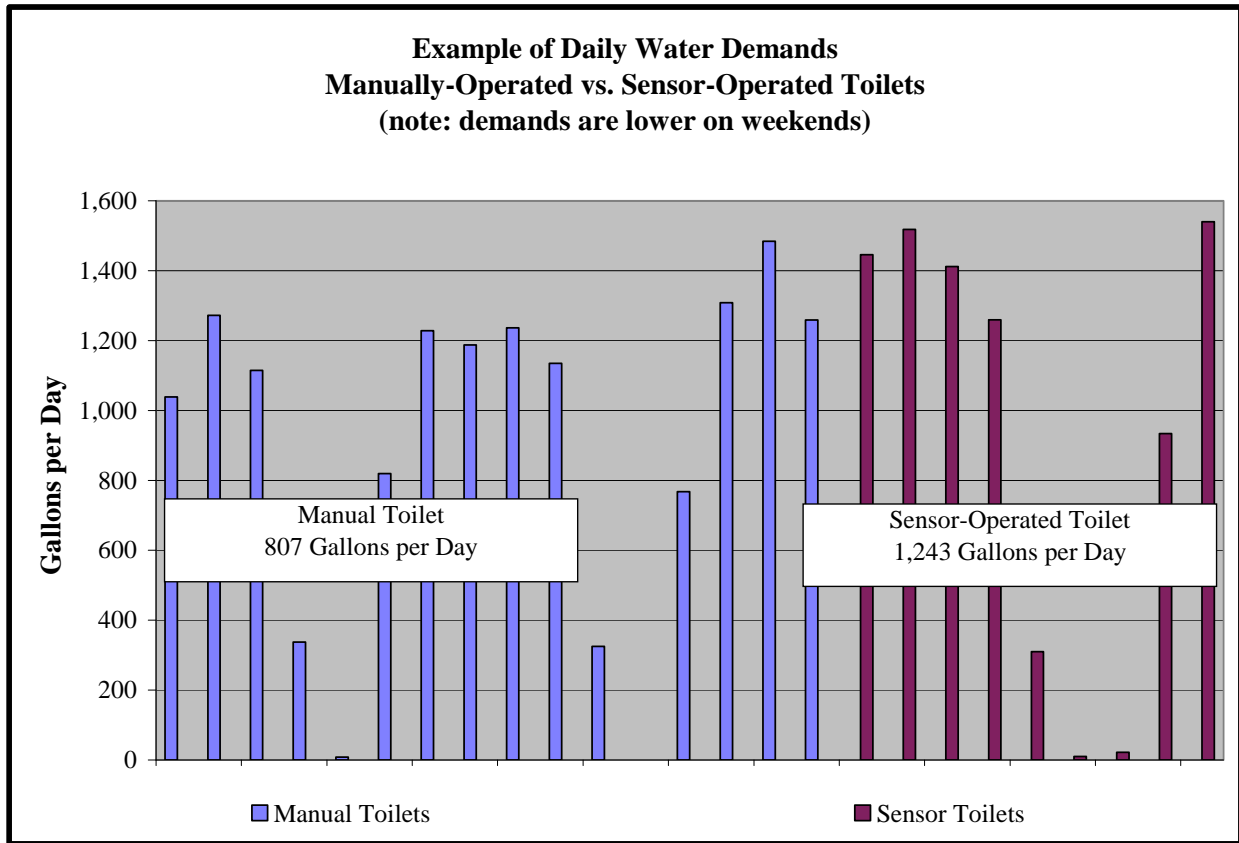
Although the data logging portion of the monitoring was concluded on September 3, 2008 (see Figure 4 on next page), a final meter reading was recorded on January 23, 2009 - a total of 151 days after the sensor-operated flush valve handles were installed on the toilets. The average water demand during this extended period was 1,243 gallons per day vs. less than 900 gallons per day before the installation of the sensor-operated toilet flush handles.

It seems likely that the increase in demand should be attributed to the conversion of both urinals and toilets to sensor-operated fixtures valves⁸. It is clear that water demands of the two washrooms on the seventh floor of the property increased from an average of 856 gallons per day before the sensor-operated urinal and toilet flush valves were installed to 1,243 gallons per day after they were installed – an increase of 45%.
