# **Toilet Flapper Study: Final Report**

## **The California Urban Water Conservation Council**

**December 15, 2004**

### **Koeller and Company**

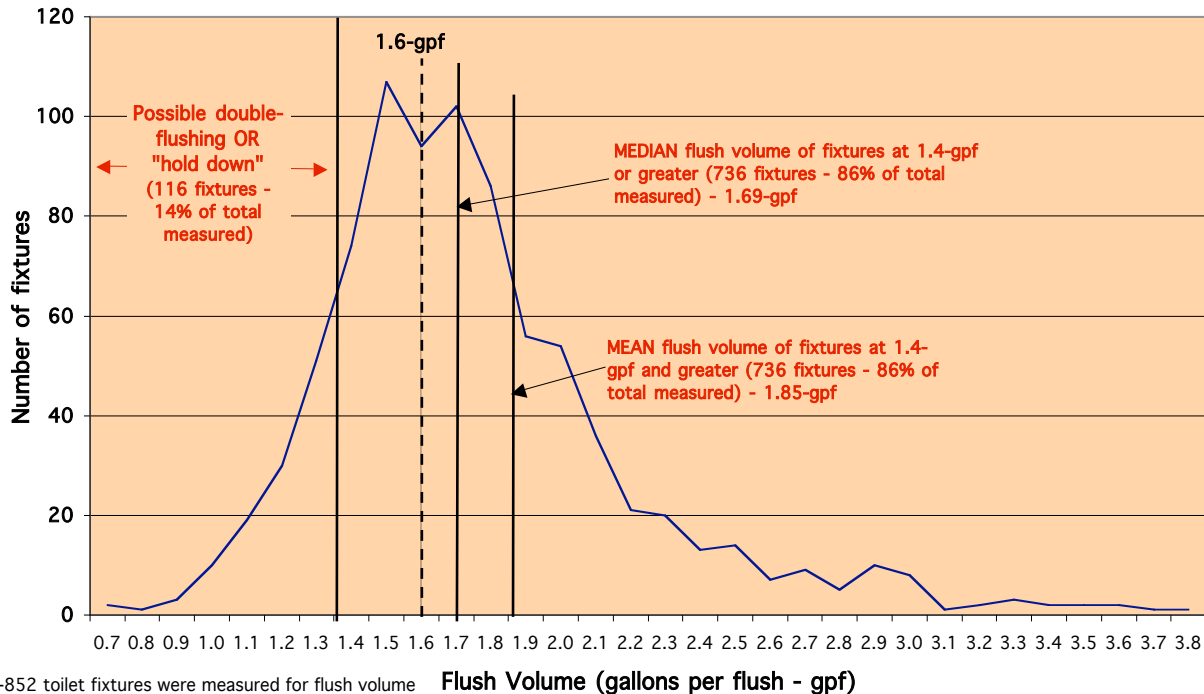
Figure 1. Flush Volumes:  
Toilet Fixtures Sold & Installed\* - 1992-2002

Overall, the mean flush volume of the 852 measured fixtures<sup>6</sup> was 1.76-gpf. Figure 1 illustrates the distribution of flush volumes of all 852 fixtures.

1. The average flush volume of all 852 toilet fixtures measured was 1.76-gpf. (Note: Refer to Figure 1 on page 10 to view the full distribution of measured flush volumes.) However, 14 percent of those fixtures flush at a volume of less than 1.4-gpf, possibly leading to double-flushing or the user’s “hold-down” of the flush handle, a common practice when water is insufficient to evacuate the waste with a normal flush. If one assumes that double-flushing does occur with the 14 percent group, the average (computed) flush volume of all fixtures then climbs to about 2.0-gpf.

1. The average flush volume of all 852 measured fixtures was 1.76-gpf. (Refer to Figure 1 on page 10 for a view of the distribution of flush volumes.) Approximately 54 percent of all aging toilet fixtures inspected were flushing at a rate of 1.7-gpf or higher (Table 5). Some of this may be due to: (1) natural “creep” of the adjustments within the toilet tank, (2) improper adjustment of the fixture at installation, (3) incorrect flush valve seal (flapper) replacement, or (4) tampering by the homeowner or others.

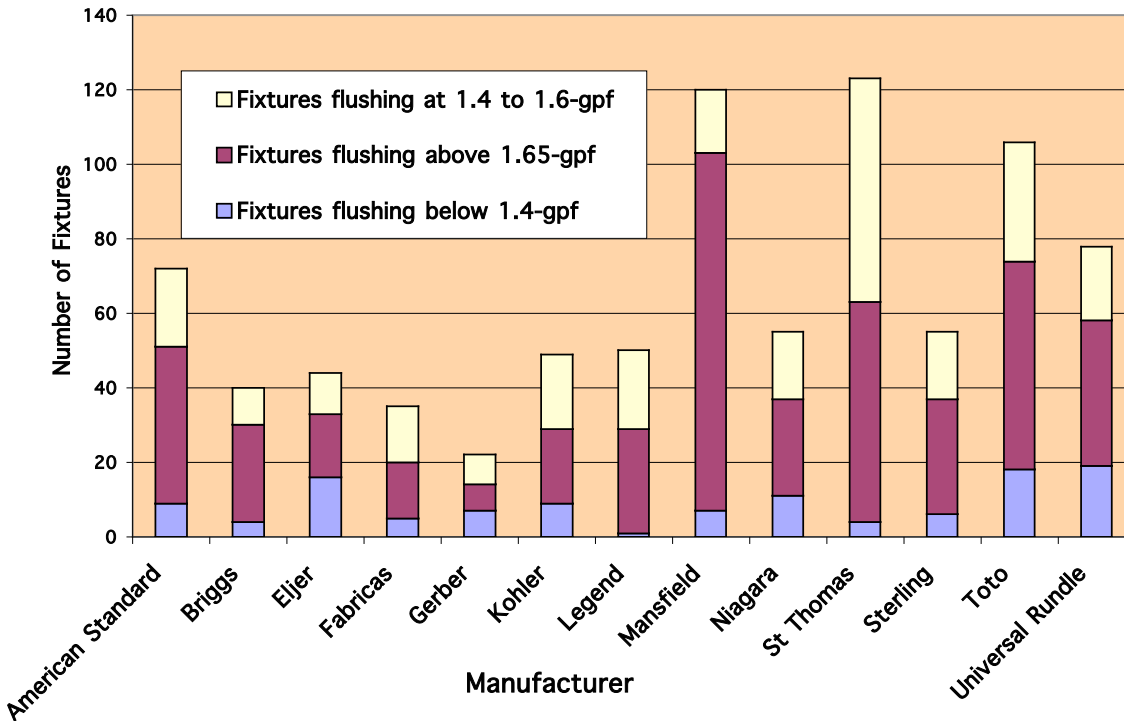
**Figure 2. Distribution of Flush Volumes - Manufacturer**

Measured flush volumes for the aging fixtures in this study varied significantly among the manufacturers (see Table 5). This variance above and below their rated flush volumes<sup>8</sup> may be attributable to several factors: improper installation and set-up of the toilet fixture (whether intentional or unintentional), normal aging of the fixture internal parts, operating water pressure variances within the residence, failure of the resident to maintain the fixture and/or re-set the water level on a periodic basis, replacement of the flush valve seal with an incorrect after-market product, tampering with the product after installation, and similar actions. The scope of this study did not include an attempt to determine the cause of the many flush volume variances.

Figure 2 illustrates the flush volumes for each manufacturer's product as listed in Table 5.

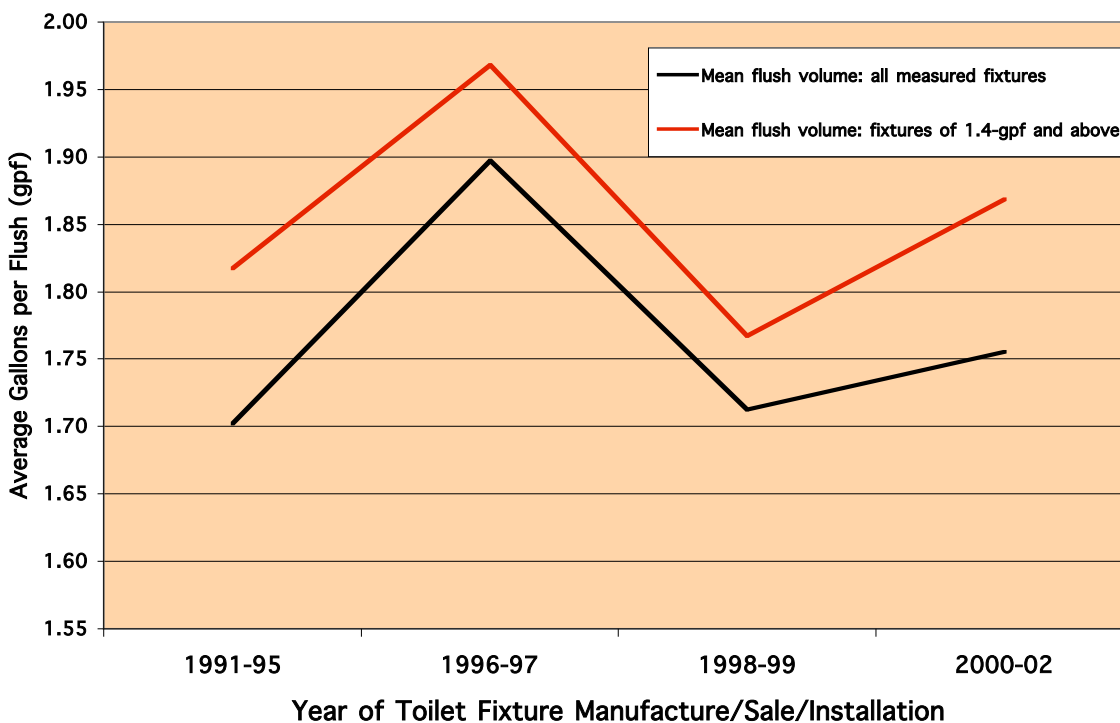
Figure 3. Flush Volumes vs. Fixture Age

Table 6 lists the adjusted flush volumes if those fixtures performing at less than 1.4-gpf are removed. Figure 3 shows average flush volumes for the four calendar periods studied.

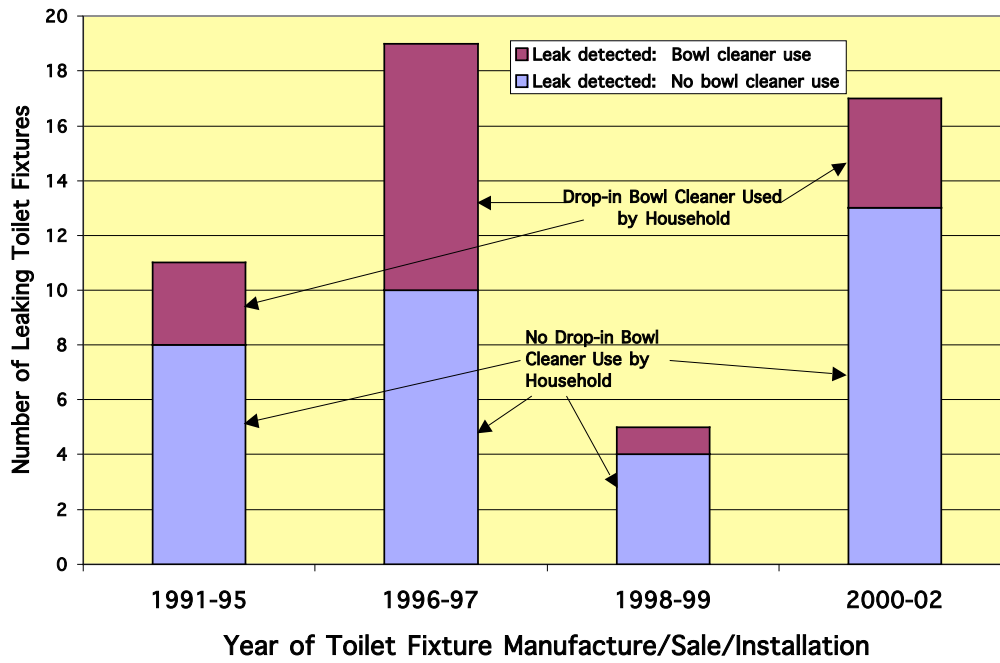
Figure 5. Leaking Toilet Fixtures and the Use of Bowl Cleaners

The results of this study appear to indicate that flapper failure (leaks) occur irrespective of the use of bowl cleaning tablets. Figure 5 illustrates the tally of responses from residents with leaking toilet fixtures when quizzed about their use of bowl cleaners. In fact, of the 52 households with a toilet leak, only 17 indicated that they had used a bowl cleaner in their toilet at any time. Figure 6 displays graphically the “overlap” of bowl cleaner users with leaking toilets within the context of all 892 inspections and surveys. Clearly, the universe of leaking fixtures is not large enough to infer that the use of bowl cleaners either does or does not lead to leaks through the toilet flapper. Nor do the responses of the 52 household residents provide any indication either way.

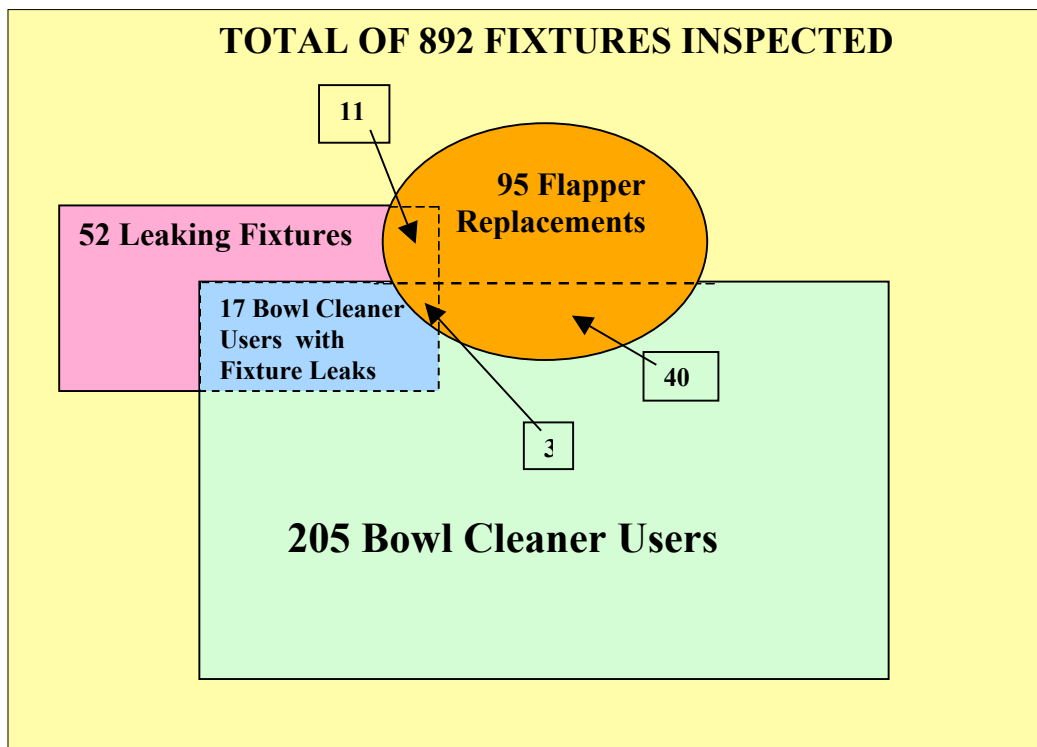
Figure 6. Bowl Cleaner Use and Toilet Fixture Leaks (not to scale)

Of the 892 households with inspected toilets, 205 (23 percent) indicated that they had used bowl cleaners at one time or another (of those, 134 stated that they were using them at the time of the visit and inspection). Tables 9 and 10 show the usage within each service area; Table 11 shows usage stratified by manufacturer.

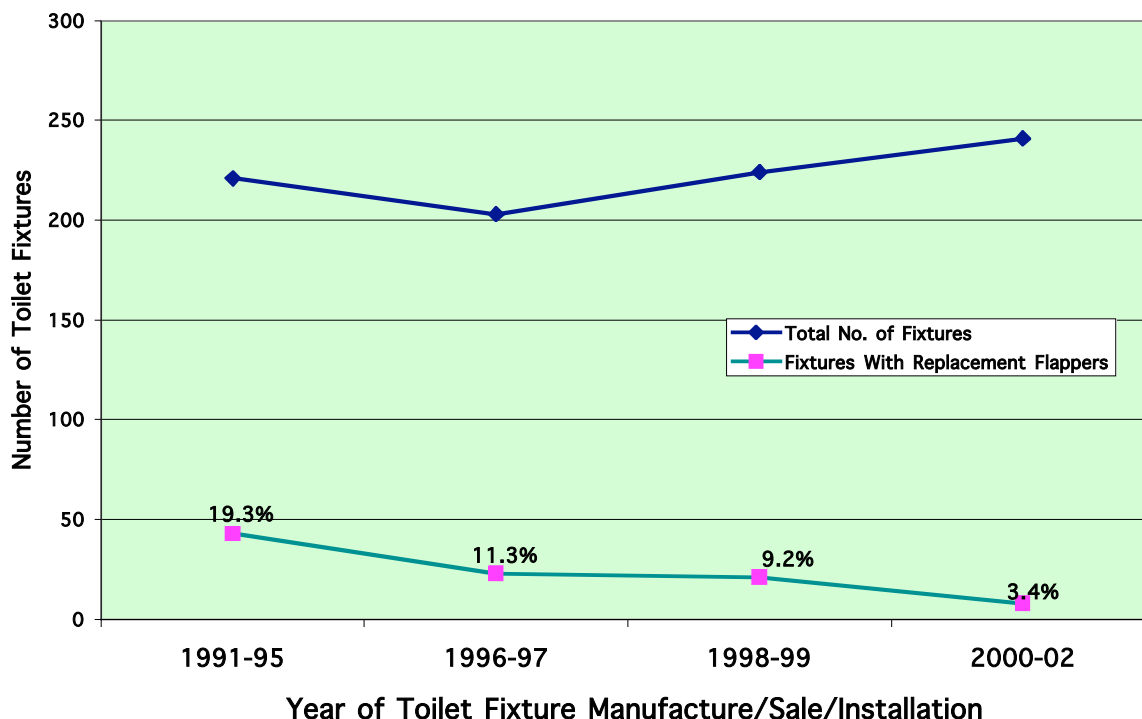
Figure 7. Replacement Flappers

When aggregated and analyzed as to the age of the toilet fixtures, the flapper replacement trend becomes somewhat more apparent. The data within Table 14 and the Figure 7 graphical representation of that data indicate that flapper replacement is not as prevalent as some may have previously believed. As noted, less than 20 percent of the fixtures within the 10-14 years of age category have had their flappers replaced at some time during their lifetime.

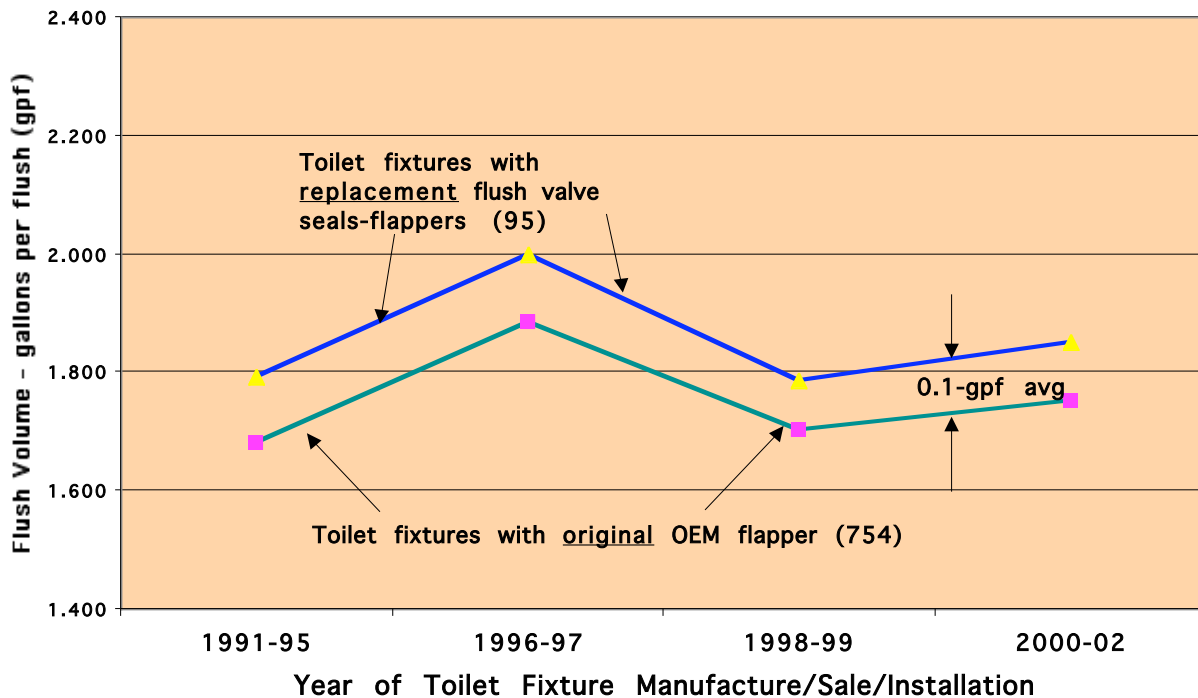
**Figure 8. Flush Volume Comparison: OEM vs. Replacement Flappers**

An objective of this study was to determine, to the extent possible, the incremental increase in flush volume occurring with flush valve seal (flapper) replacement by the consumer. Of the 852 fixtures measured for flush volume, only 95 were operating with replacement flappers<sup>16</sup>. Table 15 and Figure 8 compare the flush volumes of those fixtures containing their original OEM flush valve seal with those with replacement seals.

With the reservations noted<sup>16</sup>, it can be concluded that flapper replacement adds an average of about a tenth of a gallon to the flush volume of a low-flow toilet fixture. However, certain toilet fixture models are designed to function at close to 1.6-gpf even when the flush valve seal is replaced with a product other than that recommended by the fixture manufacturer. Conversely, other toilet fixtures use “early-closure” or other flush valve seals that, when replaced, lead to significantly increased flush volumes<sup>17</sup>. Table 16 compares flush volume variances for the fixture models included in this study.
