# TESTING TIMES 'DOWN UNDER'

Does reduced flush volume have a negative effect of the performance in the drain line? One manufacturer was keen to find out.

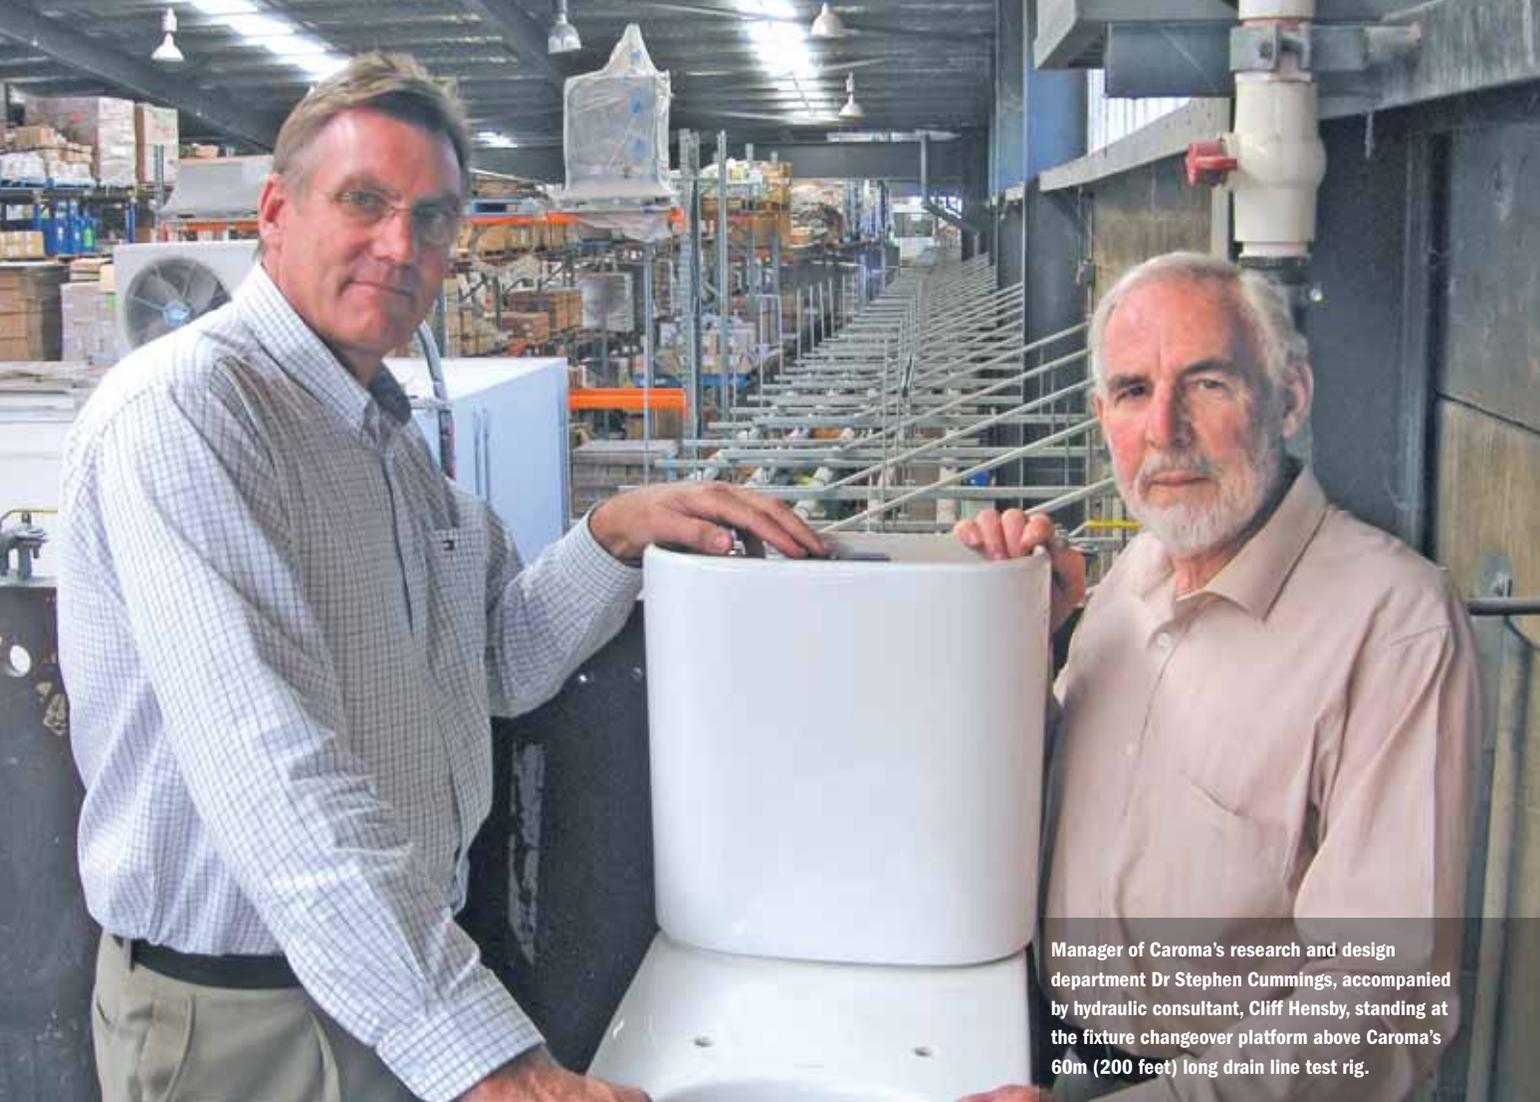
Manager of Caroma's research and design department Dr Stephen Cummings, accompanied by hydraulic consultant, Cliff Hensby, standing at the fixture changeover platform above Caroma's 60m (200 feet) long drain line test rig.

Dr Cummings initiated the design and construction of a pipeline test rig at the corporation's Sydney manufacturing centre several years ago. The elevated test platform, situated approximately 4m (12 feet) above ground level, allows toilet suites of various designs to be easily connected to 100mm (3.9 inches) and 80mm (3.1 inches) diameter

drain lines. These clear plastic drain lines, that extend for some 60m (200 feet) and form the longest test installation of its kind in the world, enable the test team to easily observe the waste flow performance from up to five of WCs set up on the rig using varying drain line grades configurations and low-flush discharges.
